Agenda Item 6

For decision – Proposal for changing the access at Henley Way

Author: Rob Holden, Environment Manager

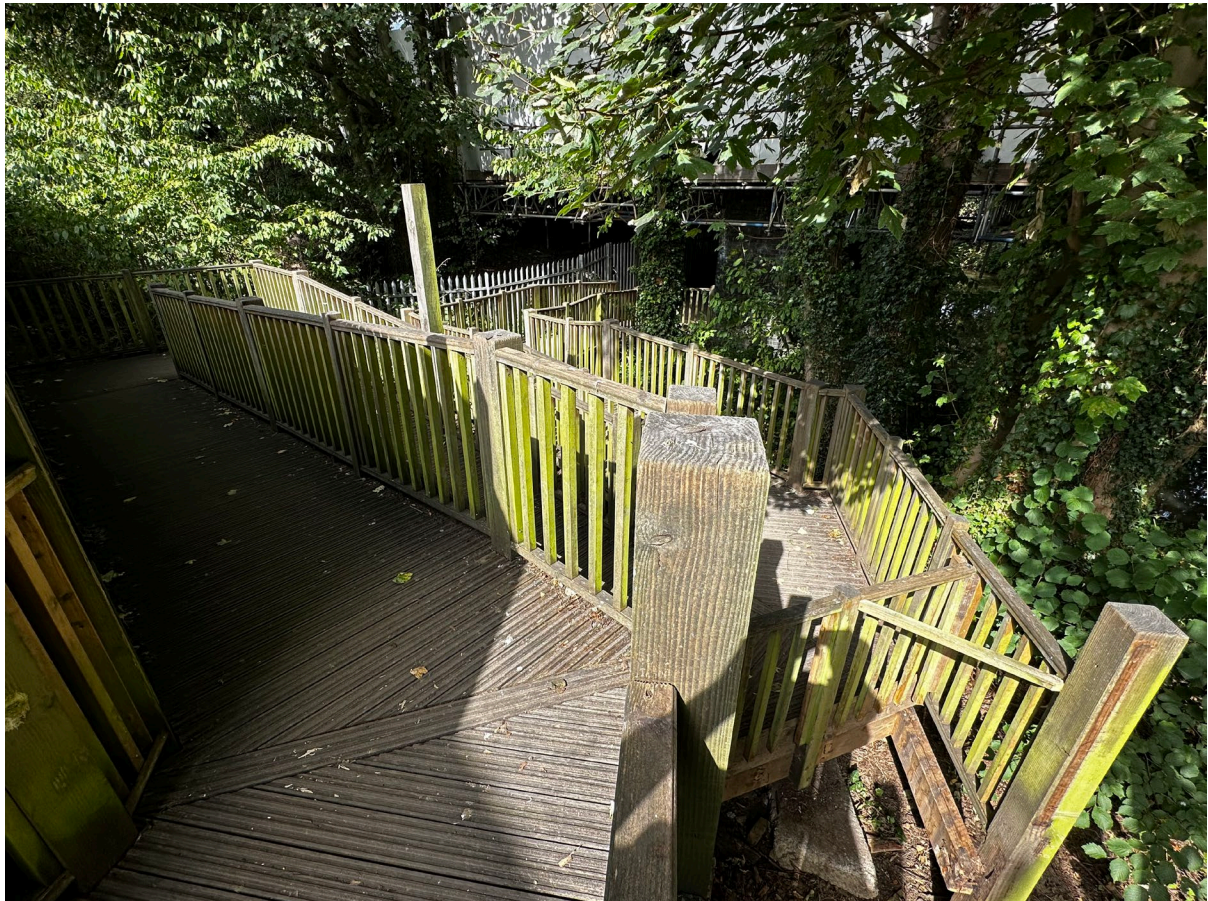
Figure 1 - Henley Way ramp as it is in early 2025

supports being fixed directly in concrete) has meant that significant rot has occurred, and we are now coming to the end of the life of the structure. The steps were retired in 2024, and the ramp has had regular remedial maintenance to extend its life but will need to be retired in the first half of 2025.

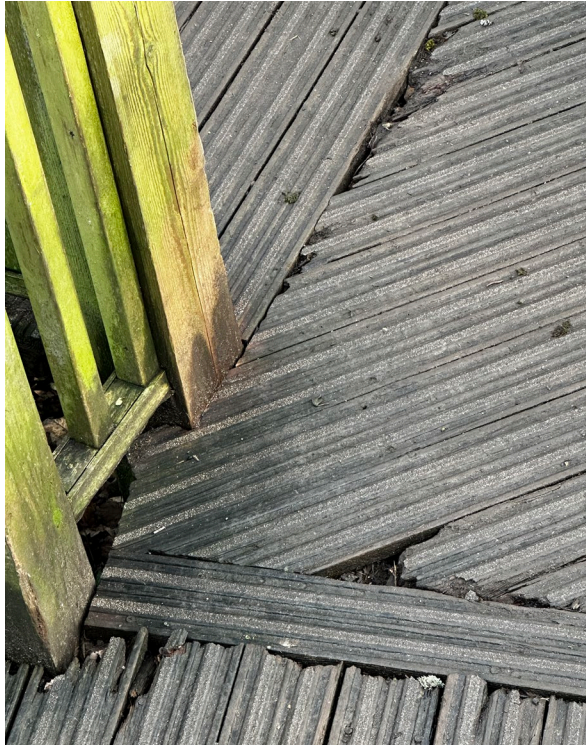
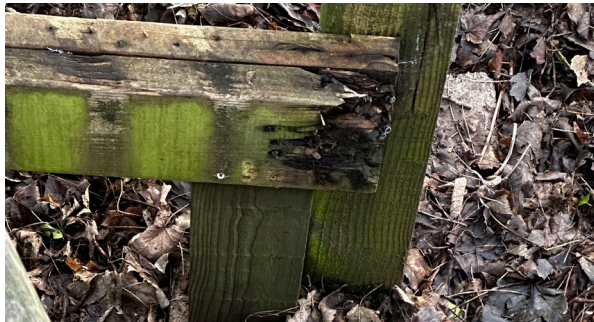
The original ramp and stairs were installed about 10 years ago. They achieved a great step forward in opening up this side of the river with a route that was accessible for all, and this route is much used by many in the community. However, the site is a challenging one for a construction in wood as it is shady and damp, underneath trees and next to a river. The location combined with the type of wood used and the construction method (structural

Figure 2 - Examples of wood reaching the end of its life

Both provide for an access compliant set of steps that would be installed in the same location as the previous steps. The treads would be in thick anti-slip metal with the nose edging of each step painted with a high visibility contrasting colour (eg white). The vertical balustrade would be powder coated black and the handrail in a more tactile wood that can be maintained and replaced at little cost when it needs retiring.

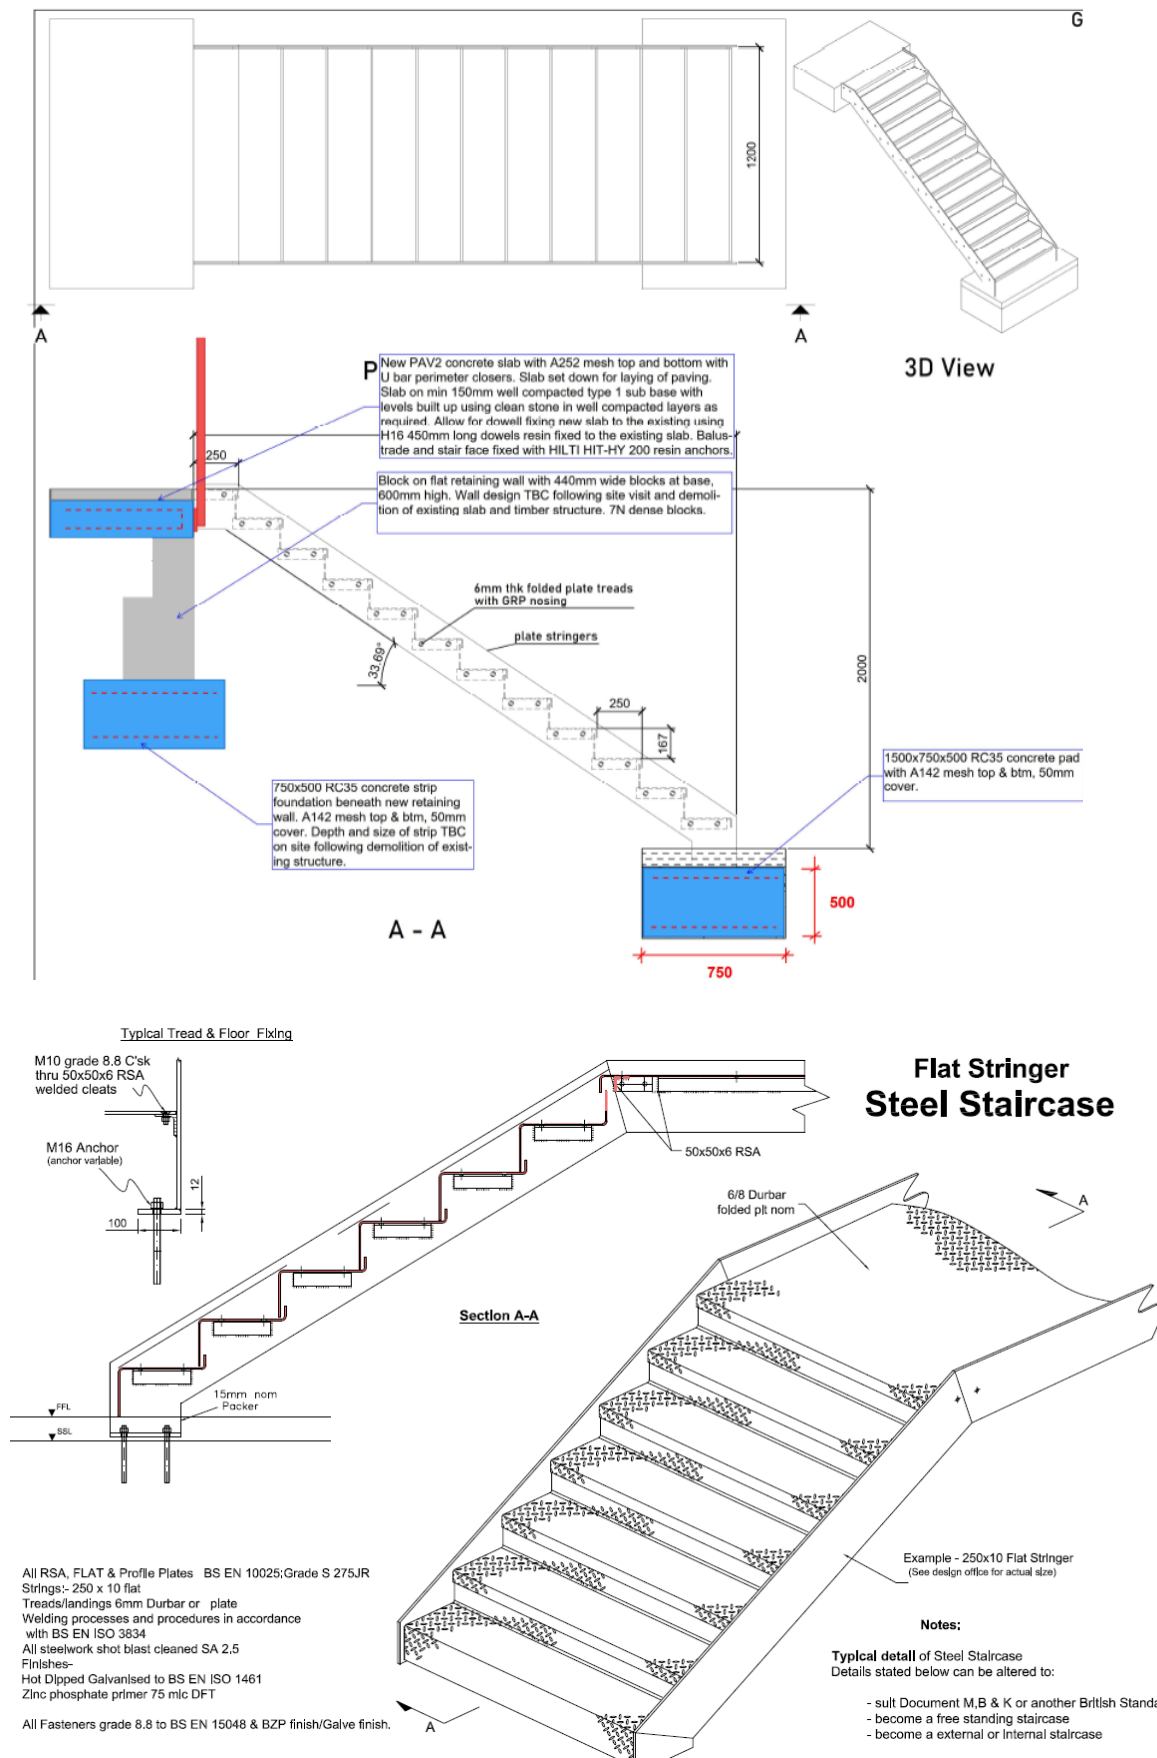
Figure 3- Examples of steps design detail not including balustrade and handrail. Note: indicative draft only, not final design

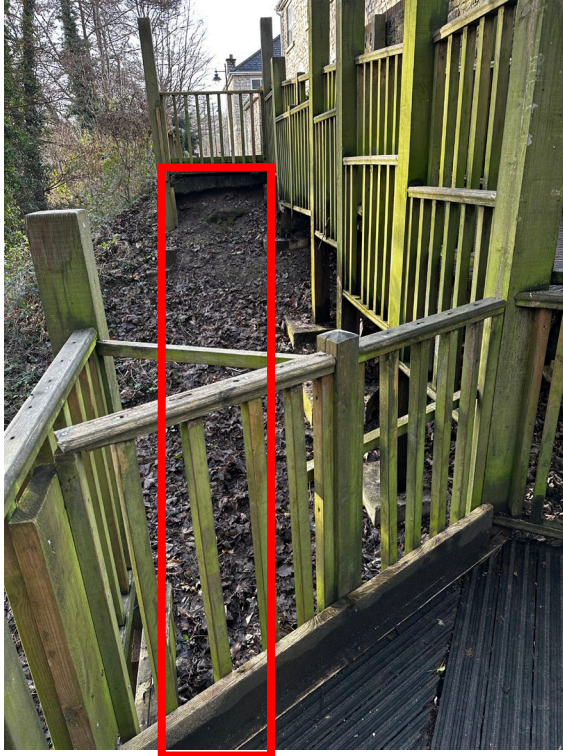
Figure 4 - Steps could be installed to the side of the existing ramp in the place where the previous steps were located

The location of the steps would in the same position as the previous steps leaving the space used by the current ramp free for a future project should funds be found.

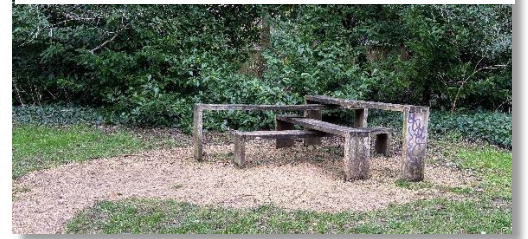
- Comfort stops – some of the benches are currently difficult to approach in a wheelchair and have no wheelchair seating options – adapt or change
- Benches that have no backs or arm rests are less accessible – introduce benches with both

Figure 7 - Existing bench with back or armrest
